Building Assessment & Renovation Analysis

Banta Center

605 Beech Street
Valparaiso, Indiana

March 1, 2019

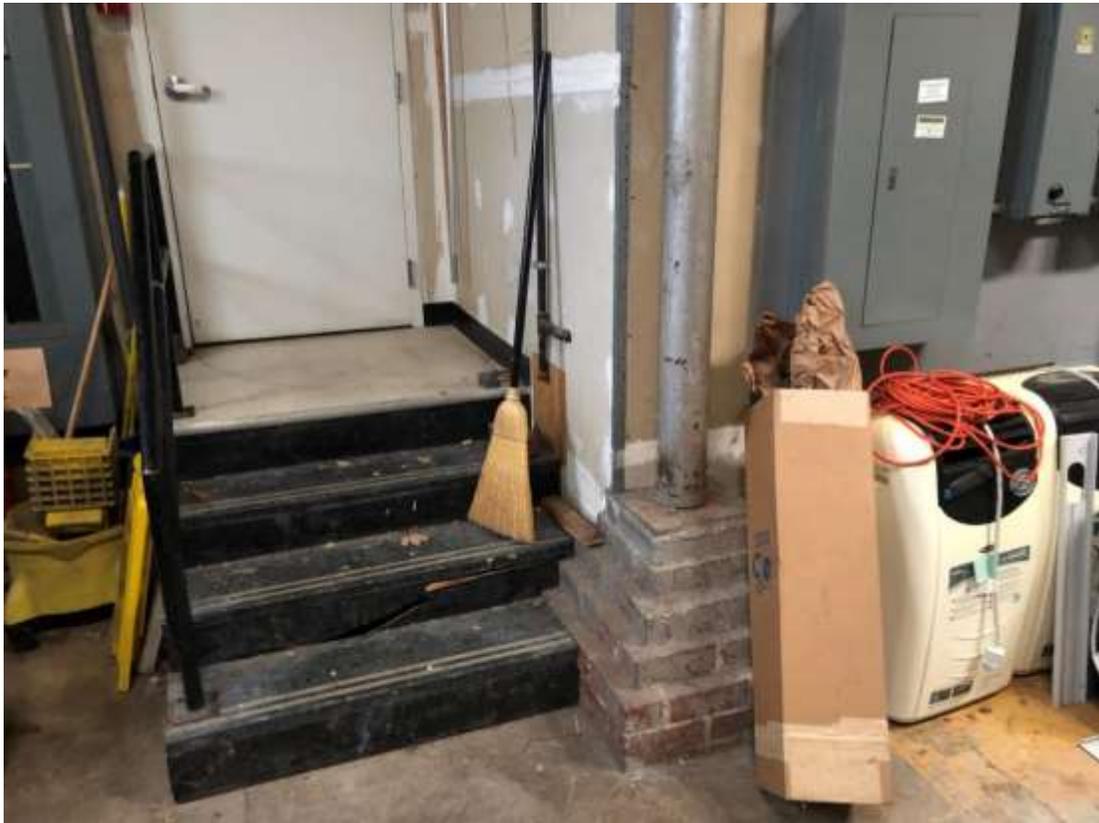
Figure 1: Mechanical Room Column

- Crawlspace was not accessible. Inspection of first floor structure and interior foundations could not be performed.
- The mechanical room column appears to lack positive connection to the existing pier.
- The director's office floor in the southwest corner of the building exhibits moderately excessive deflection. Inspection of the area through the crawlspace is recommended to determine the cause of the deflection.

Recommended Repairs: Anchor pier to baseplate.

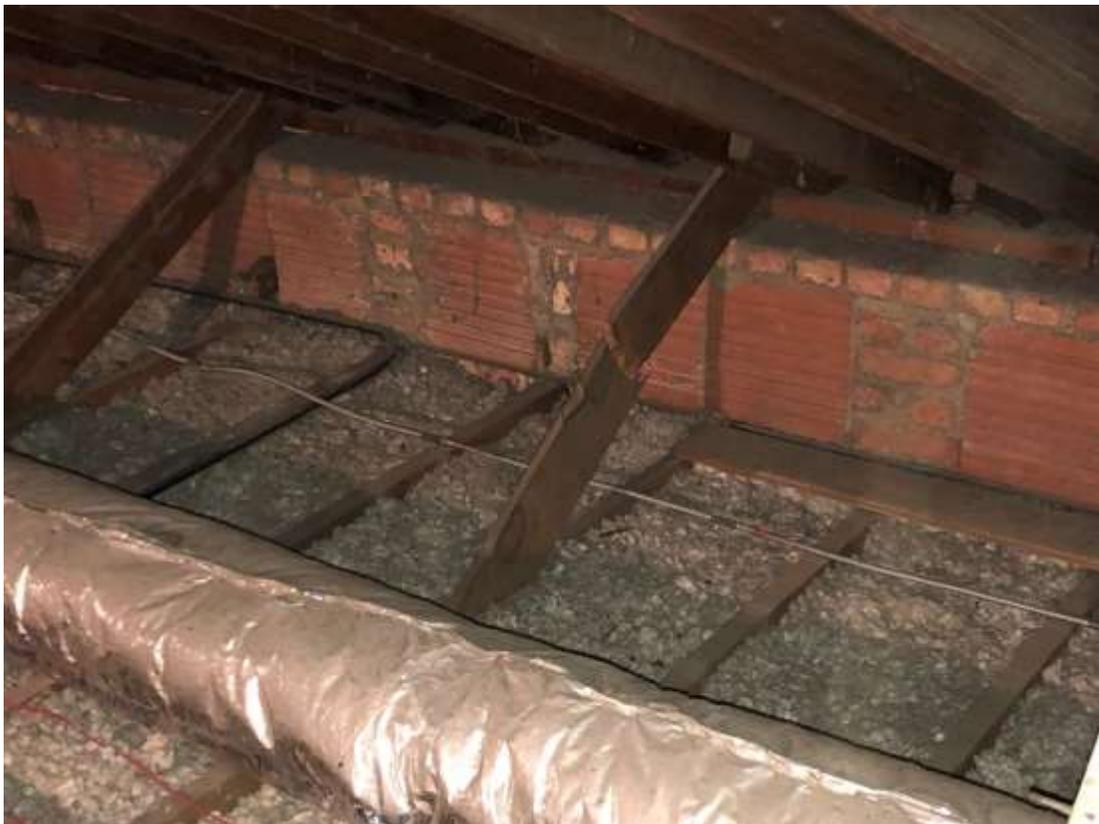
Figure 2: Roof Uplift Brace

Additional uplift resistance is provided by dimension lumbar hold-down braces nailed to the rafters and the attic joists at approximately 6 foot spacing. One of these hold-down braces has been broken and should be replaced with like.

- One damaged hold-down brace should be repaired or replaced.
- The degraded stub walls should be repaired or replaced.

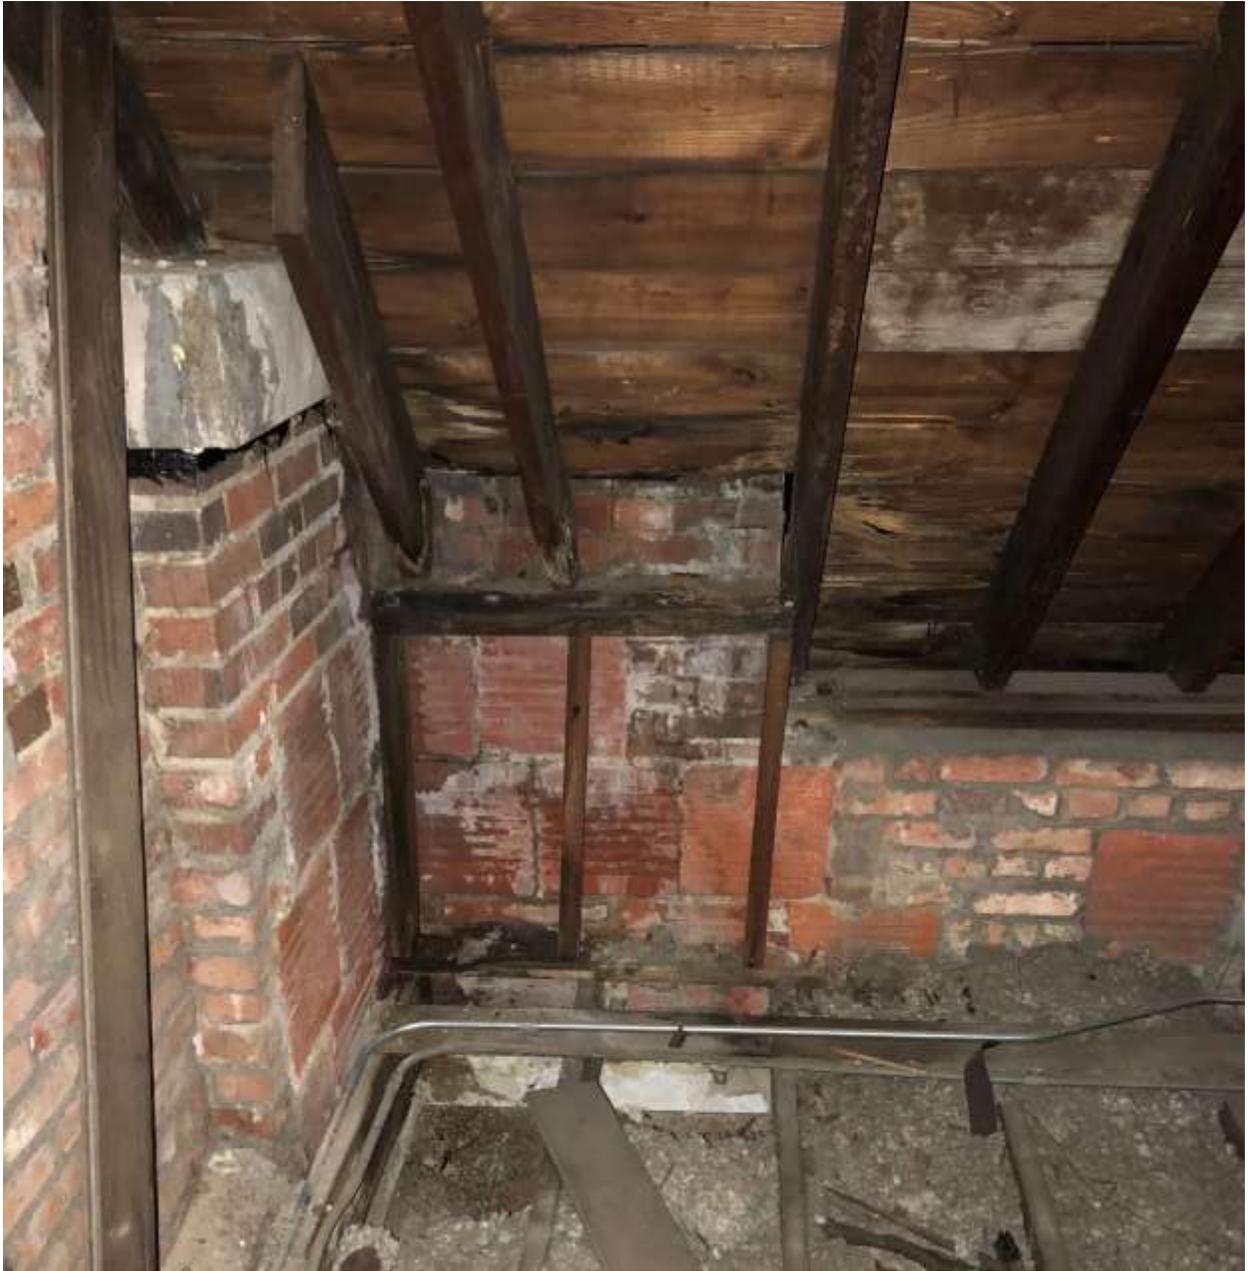
Figure 3: Northeast Gable East Roof Stub Wall

In eight locations, the corners of the gable end walls, there are areas where water has entered the building envelope and caused significant degradation of the stub walls that bear on the roof joists, supporting 2 or 3 rafters (Figure 3).

The stub walls should be replaced or reinforced at all 8 locations. This water infiltration may be exacerbated by the lack of significant insulation in the attic area, potentially leading to ice dams.

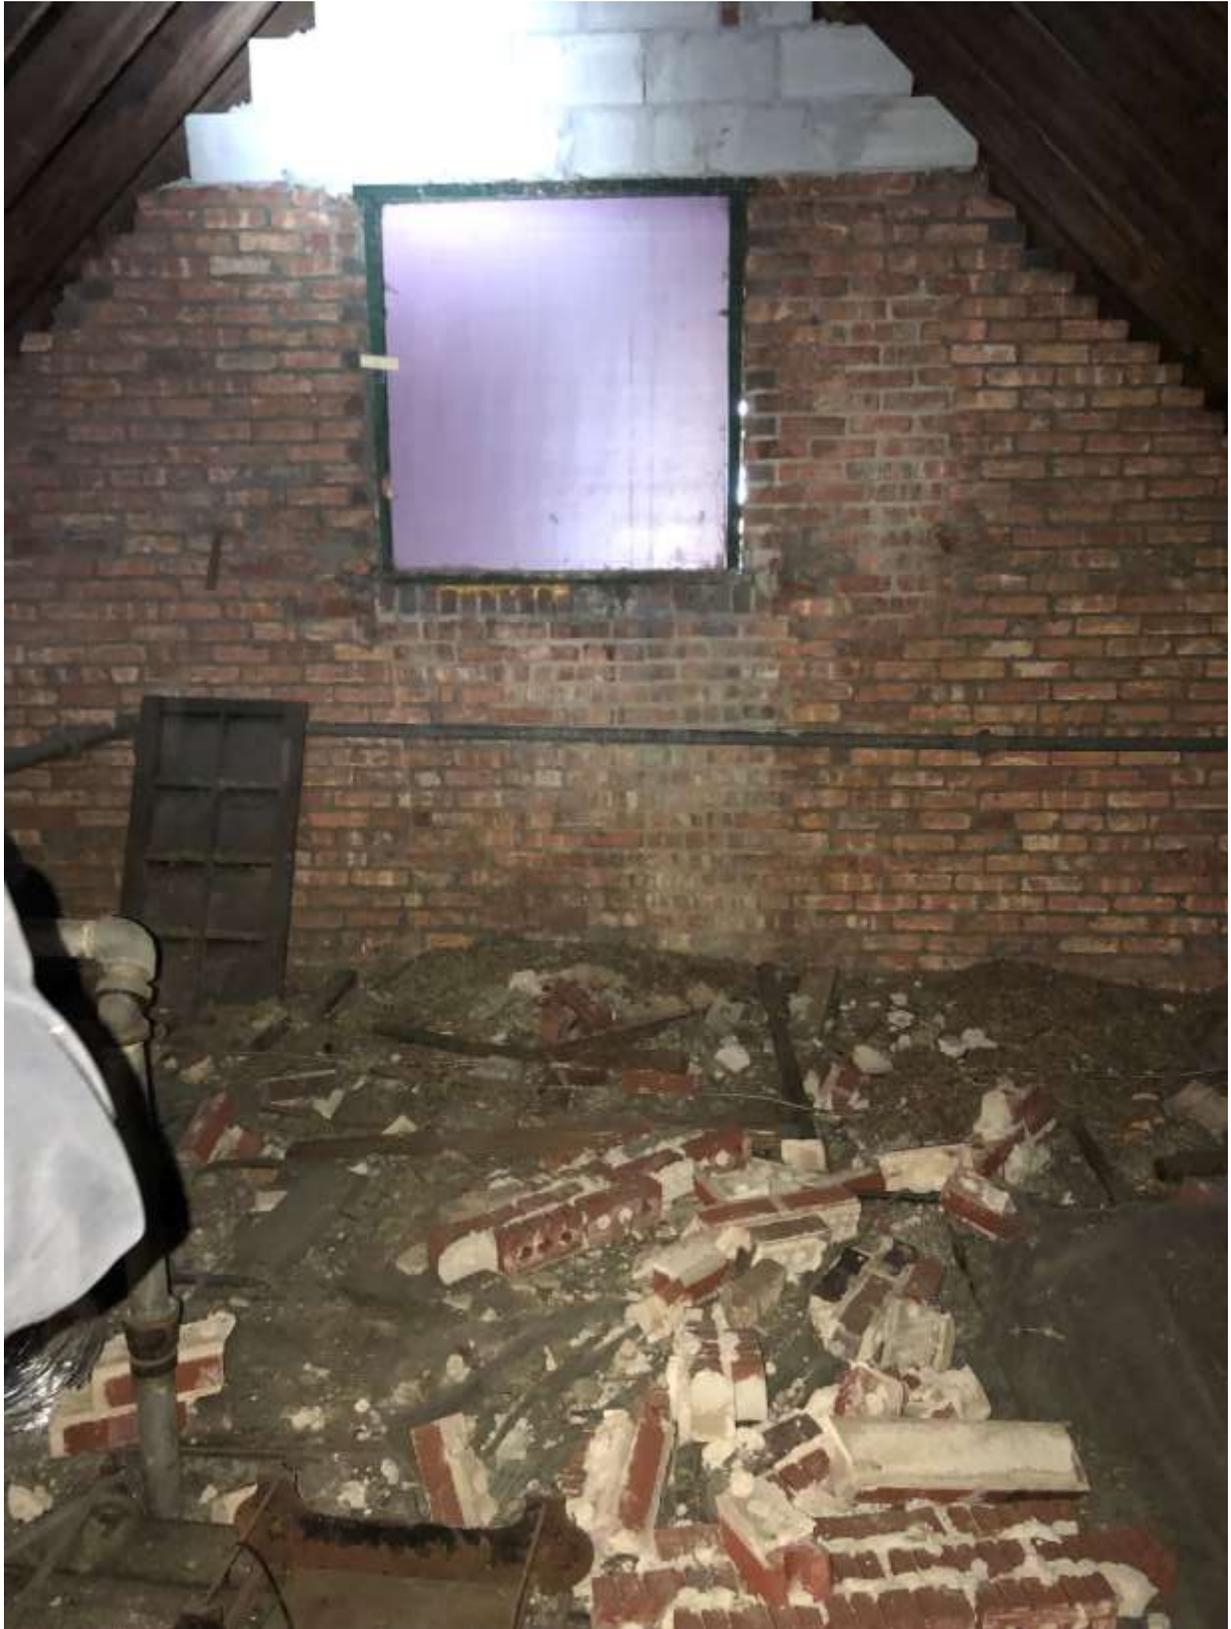
Figure 4: Northeast Gable - Repaired Gable End Wall

The gables end of the northeast gable has been repaired. The interior two wythes have been removed and replaced with concrete block (Figure 4).

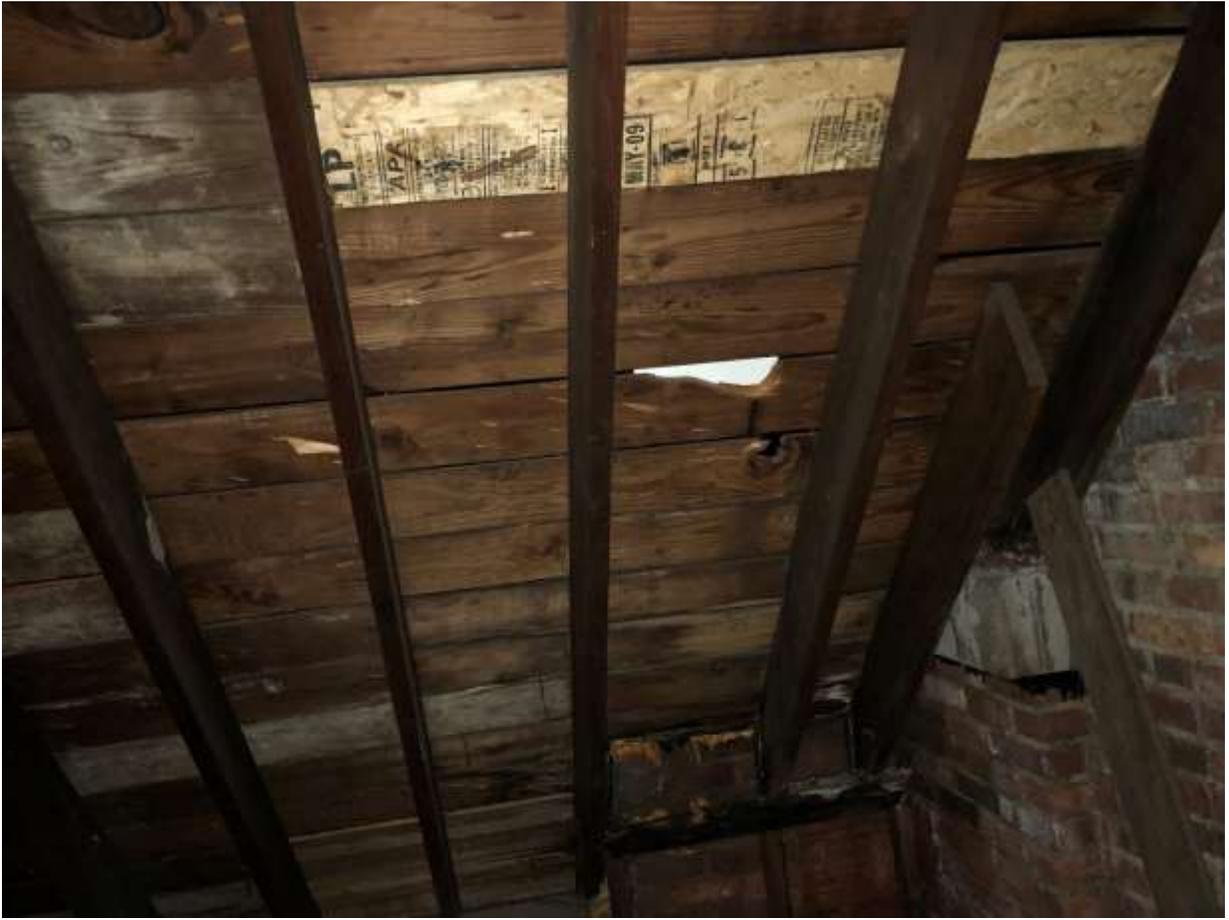
Figure 5: Repair of Roof Planking

The roof decking is composed of 1x6 boards flatwise spanning perpendicular to the rafters. Various repairs are present, mainly at added and removed roof penetrations. The roof decking is in good condition (Figure 5). The building paper appears to be in good condition, see architectural report regarding roof flashing and shingles.
