Valparaiso Park Dept. Adult Activity Center Analysis Report

March 8, 2021

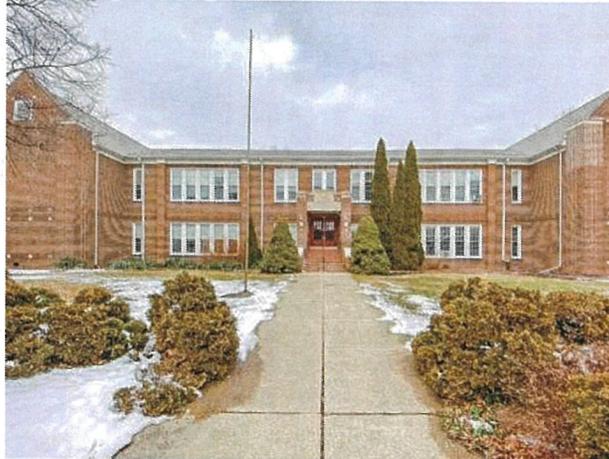
- » The mortar joints above the upper corners of most of the windows exhibit extensive diagonal, "stair step" cracking. This cracking pattern at the top of the windows is indicative of corrosion of the steel angle window lintels. The cracks form due to the corrosion of the lintels lifting the brick above the opening, a process commonly referred to as "rust

jacking". In addition to tuckpointing these cracks, the lintels may need to be exposed to be cleaned and coated with a corrosion inhibitor and to install proper flashing.

- » The plaster at the interior is cracked at many of the window lintels. This is also likely the result of the lintel deterioration.
- » The interior plaster exhibits some water damage along the tops of some of the

exterior walls. This occurs mostly at the gable ends of the 2nd floor of the building. The roofing, parapet masonry, and flashing in these areas may need repair or replacement to prevent further water intrusion.

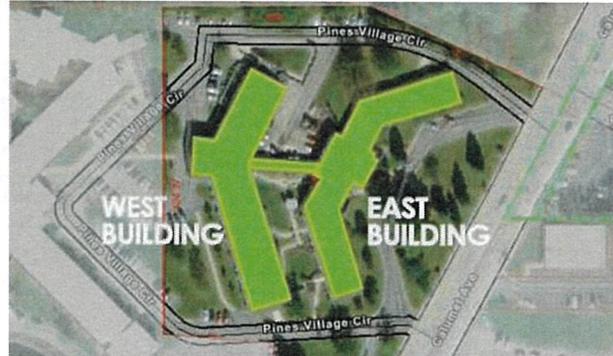
- » The east 1960's building is two-stories at the south end and center portion. The north wing of this building is one-story. The grades around the building slope up from the south end to the north end, allowing the one-story north wing to be located at the upper level of the balance of the building.
- » A small portion of the west corridor wall appears to have been removed near the diagonal turn in the corridor. The studs appear to have been

trimmed above the ceiling and no replacement support has been provided for the roof joists. A new beam should be designed in this area.

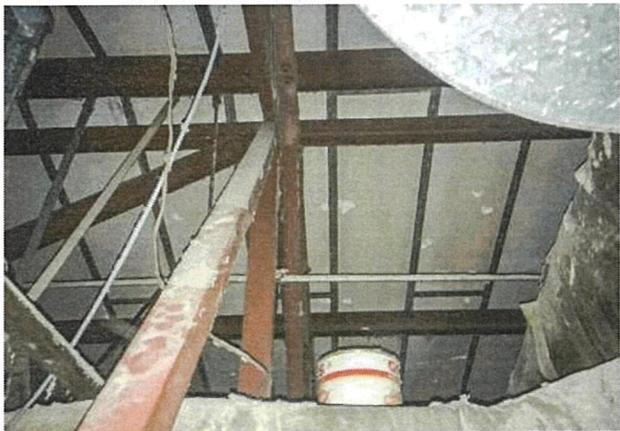
- » Most of the upper level interior walls appear to be non-load bearing and could easily be removed to open up larger areas.
- » The exterior finish consists of brick and stone masonry veneer. The masonry veneers exhibit some deterioration and cracking. The deteriorated mortar joints should be tuckpointed.

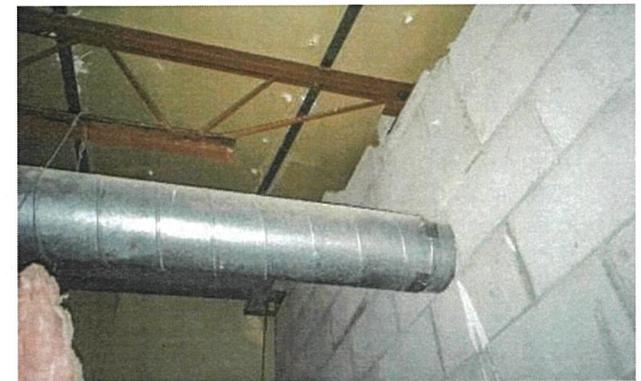
- » Approximately half of the interior walls are load bearing CMU and if removed would require significant steel framing to support the floor and roof framing. The non-load bearing partitions appear to be easily removed without structural impact to open up moderately sized areas.
- » The exterior finish consists of brick masonry veneer at the north and south ends and at the main entrance canopy/wing. The masonry veneers exhibit some deterioration and cracking. The deteriorated mortar joints should be tuckpointed.
- » A downspout has been removed at the southwest corner of the building, leading to extensive deterioration of the brick veneer in this area.

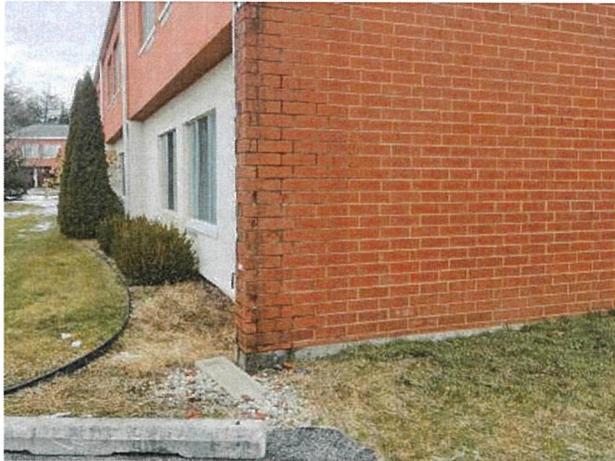
- » The longitudinal building walls appear to have an EIFIS finish. This finish is cracking and deteriorated in some areas such as around the windows. This should be repaired and re-painted.

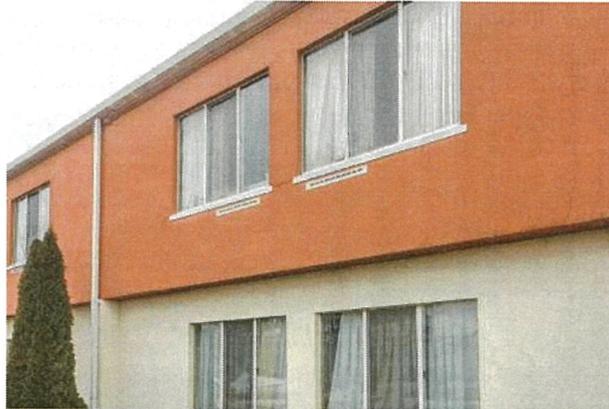
- » The second floor extends out over the main building entrance to create a covered drive. The south elevation exhibits extensive damage. This appears to be impact damage from an oversize vehicle attempting to pull under this floor extension/canopy. The EIFIS finish and soffit framing in this area need to be removed and repaired. At the time of finish removal, the structure in this area should be inspected and repaired as necessary.
