Valparaiso Park Dept. Adult Activity Center Analysis Report

March 8, 2021

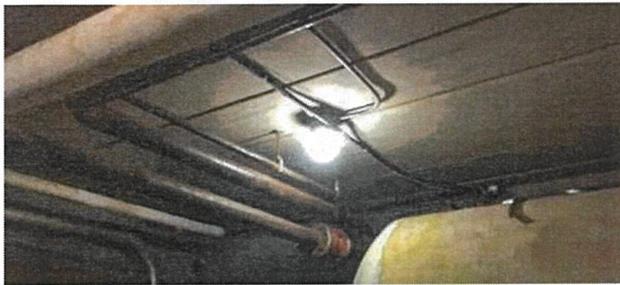
- » The two-story portions consist of concrete slab on grade lower floors, concrete masonry (CMU) bearing walls, precast concrete upper floors, and steel truss roof framing.
- » The 2nd floor is framed with "Flexicore" precast concrete hollow-core planks with a concrete topping. The planks span from the exterior walls to the load bearing masonry corridor walls.

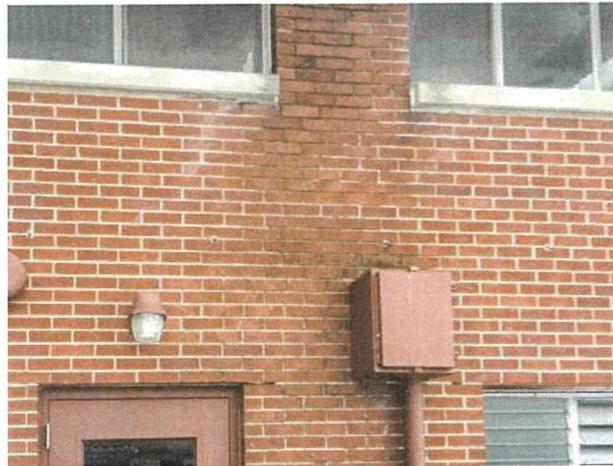
- » Most of the upper level interior walls appear to be non-load bearing and could easily be removed to open up larger areas.
- » The exterior finish consists of brick and stone masonry veneer. The masonry veneers exhibit some deterioration and cracking. The deteriorated mortar joints should be tuckpointed.

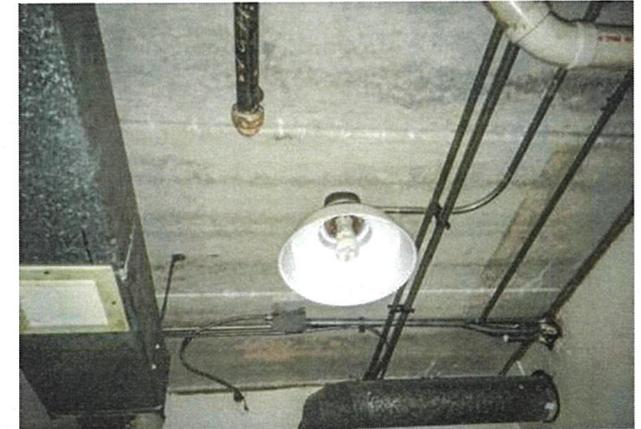
- » The west 1970's building is two-stories in its entirety. The structure consists of concrete slab on grade lower floors, concrete masonry (CMU) bearing walls, precast concrete upper floors, and steel truss roof framing.
- » The 2nd floor is framed with "Flexicore" precast concrete hollow-core planks with a concrete topping. The planks span approximately 28' between interior CMU bearing walls that run between rooms. The walls between the resident rooms alternate between load bearing CMU and non-load bearing metal stud partitions. The

bearing walls are staggered on opposite sides of the center corridor.
